# **POTENTIAL ENVIRONMENTAL CONSTRAINTS & RESIDENTIAL AND COMMERCIAL DISPLACEMENTS PLATES**

### US 69 / LOOP 49 NORTH LINDALE RELIEVER ROUTE

CSJ: 0190-04-033  
SMITH COUNTY

### **PROJECT AREA PHOTOS**

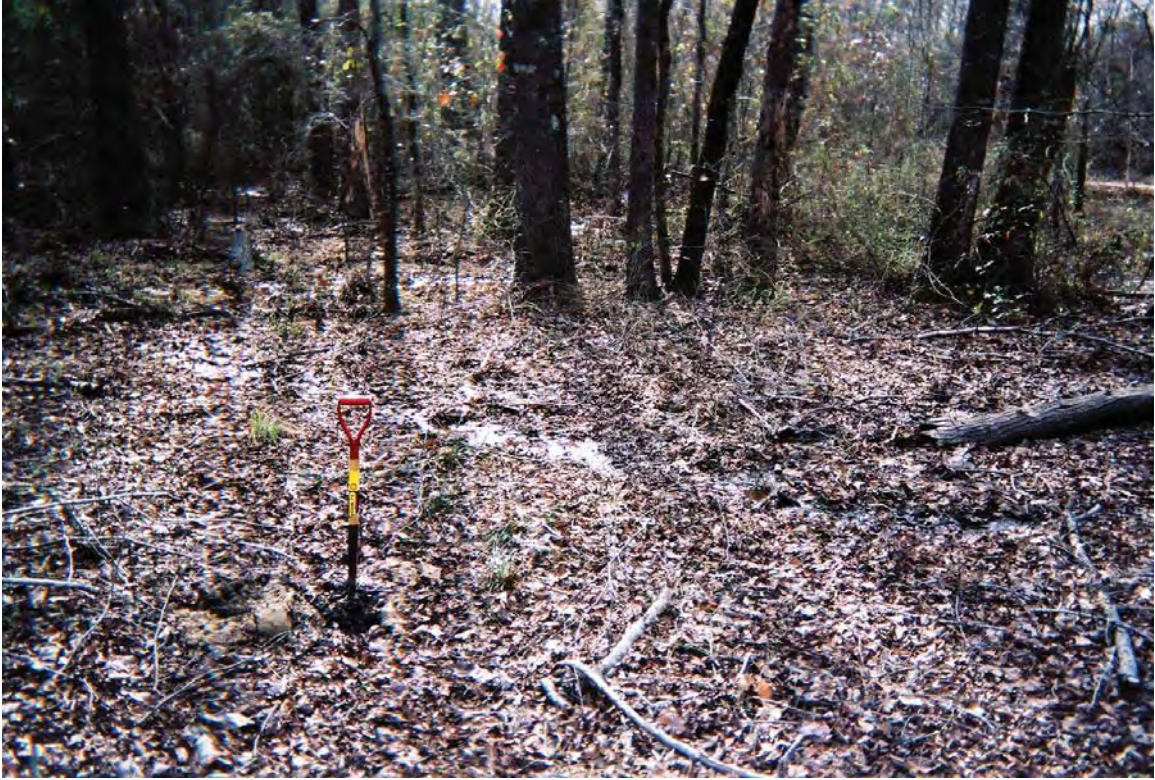
Wetland at Davis Branch, both alternatives.
